Review for Extraordinary Meeting – February 6, 2007

Company:
Attention: Bruce Pomeroy
Reference: Brickwod Place
Project No. 50-211

From: Daryl Massey
Date: January 29, 2007
Sheet 1 of 6

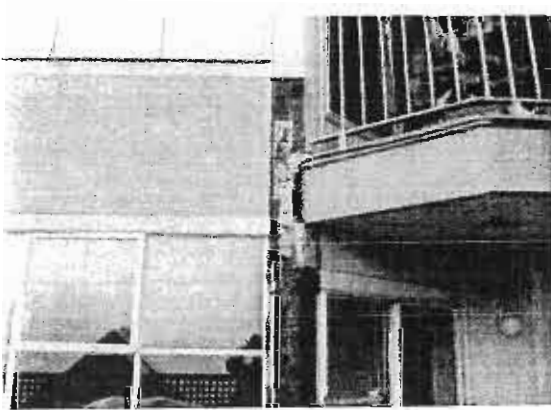
Demolition at Deck Edge 110

This photo shows the typical pattern of demolition and wall damage found at the decks above units 106, 108 & 110

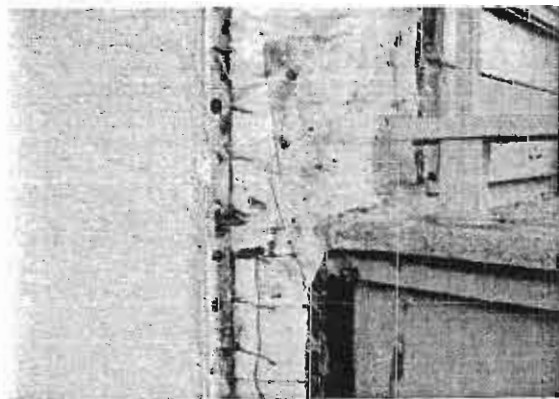
Typical Deck Edge Detailing

- 1) At 4 of the 6 locations of deck edges, the water damage is continuing up the wall above the deck edge.
- 2) The deck vinyl has been installed without a significant "boot" at the wall junction to ensure a reasonable lap with the building paper and wall membranes.

- 3) The previous repair consisted of a Self Adhered Membrane installed behind the vinyl decking approx. 1' up and 1' down from the deck edge. This membrane appeared to have been applied on top of the existing building paper resulting in a "back-lapped" condition at the deck edge and at the top of the SAM where it meets the existing building paper. The SAM was returned along the deck edge framing and under the clad deck edge fascia and was terminated vertically at the stucco expansion joint approx. 8" from the deck edge.

Several key issues are evident here which include: lack of vinyl decking "boot", back-lapped vinyl to SAM, lack of deck edge drip flashing, top mounted deck rail, no diverter at deck edge.

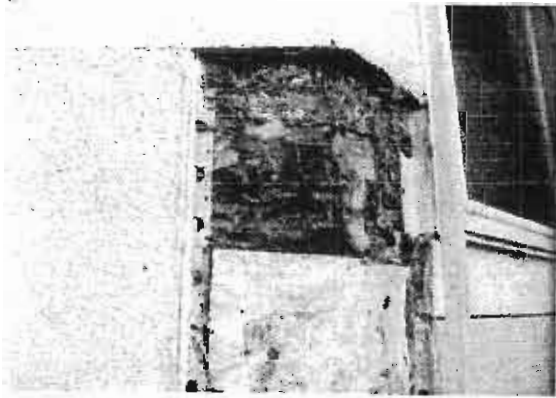
Deterioration Above Deck Edge

- 4) The wall areas above and below the SAM were soaking wet with significant damage to the wall sheathing. When the SAM was peeled back the wall area behind was equally soaked and damaged indicating that water was migrating down the wall behind the building paper from the wall and deck edge above. The original building paper was completely deteriorated and crumbled off during the demolition.

4 of the 6 deck edges showed the same type of damage above the previous deck edge repair. Sheathing is water soaked and deteriorated, building paper is completely deteriorated.

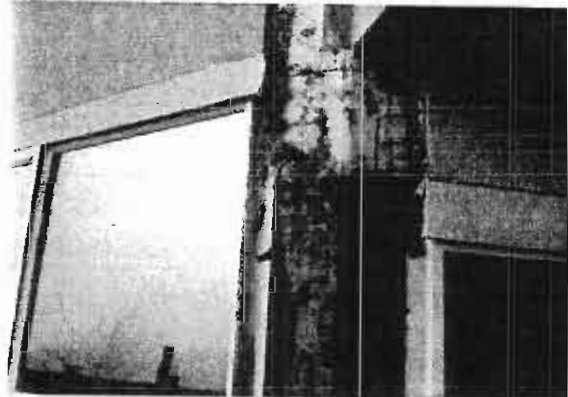
Deterioration Below Deck Edge

All 6 areas suffered water ingress damage below the deck edge. The previous repair detail simply diverted water entering into the wall system to the wall area below the deck edge.

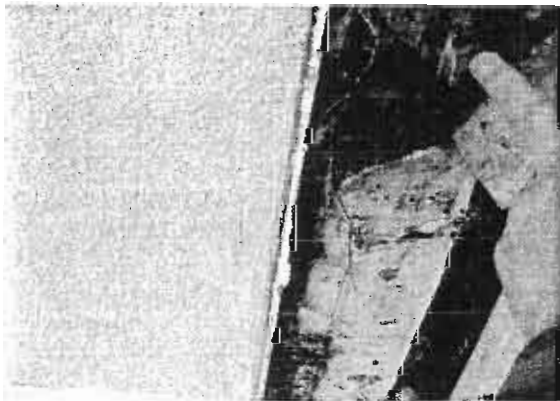
Deterioration Behind The Repair Area

The sheathing behind the previous repair was water soaked and deteriorated. The water entering into the building envelope from above easily moved through the wall system behind the SAM.

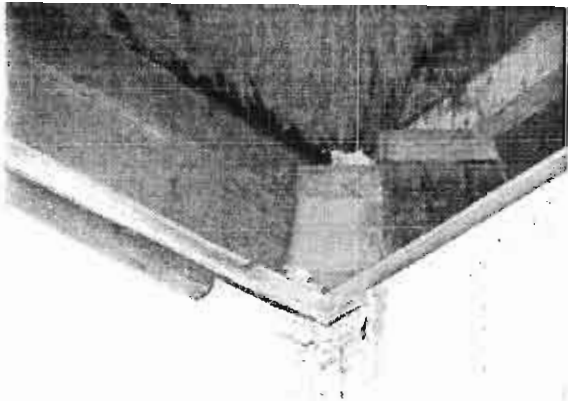
Soffit Area Below Deck of Unit 106

- 5) The soffit area at the deck edge of unit 106 was opened to review the condition of the deck framing and sheathing. The framing was just starting to deteriorate and the sheathing was wet and becoming water damaged at the deck edge.
- 6) Previous attempts to repair the deck edges were evident. These repairs consisted mostly of sealant being applied directly at the deck edge, at cracks and joints near the deck edge, and at the junction of the deck fascia to the stucco wall at the deck edge. Given the current state of water ingress at these locations it is safe to assume that these repairs have been largely ineffective.
- 7) During rainfall, water is seen dripping from the soffit areas beneath the deck areas indicating that there is significant and widespread vinyl decking membrane failure. Several of the aluminum soffit areas show staining and water damage.

This photo shows that water damage is starting to occur to the deck structure at the deck edges. Water is getting past the previous repair attempt.

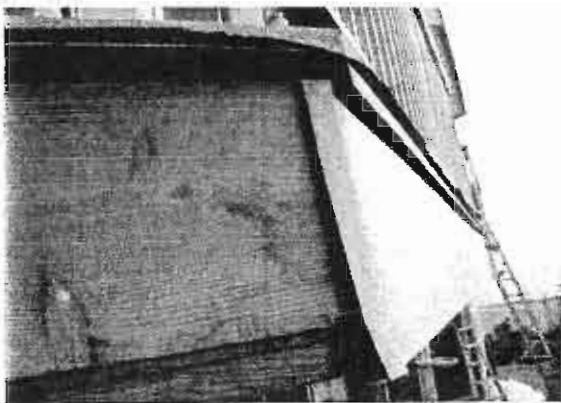
Deck Edge Detail:

The existing deck edge detail shows that the vinyl has de-bonded, there is no deck edge drip flashing, and no building paper behind the deck fascia flashing.

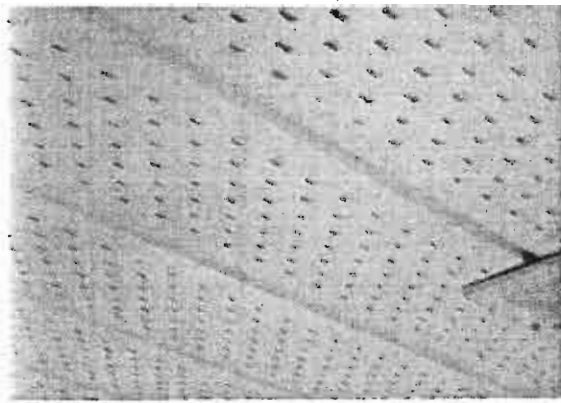
Dripping Soffits:

During regular rainfalls, water was dripping through the soffit areas of all three decks. This would indicate a serious membrane failure to the deck above.

As a result, I would recommend consideration to an expanded scope of work which would include the replacement of deck membranes to the 9 deck areas above units 106, 108 and 110. This work would include repair to the wall area and deck structure damage which may be encountered during the course of this work, and the inclusion of corrected deck, membrane and rail application details.
