Company: The Owners, Brickwood Place  
11595 Fraser Street  
Maple Ridge  
Attention: Christopher Kearney  
Reference: Waterproofing deck over u/g parkade  
11595 Fraser Street

Please find the attached Site Visit Report.

**Company:**  
**Attention:** Bruce Pomeroy  
**Reference:** Brickwod Place  
Project No. 50-211

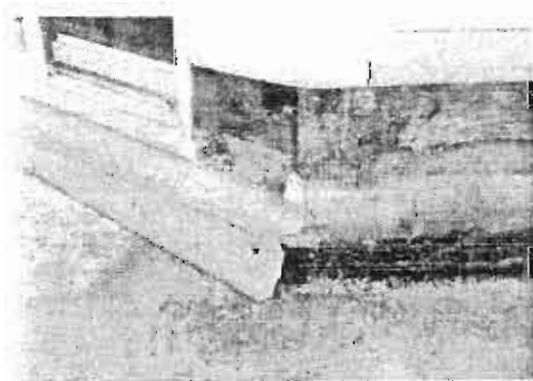
**Base of Wall Beneath Deck Edge 108**

- 1) At each of the 3 units, it is apparent that water is gaining access into the building envelope from the deck edges above. The stucco at unit 108 was opened up to the deck edge and significant structural damage has occurred. All three units show considerable damage and active water penetration at similar locations below the deck edges.

The wall below the deck edge of unit 208 shows significant deterioration as a result of water ingress from above.

- 1) Further stucco removal is required at the deck edges above units 106, 108 and 110 and the corresponding walls below to expose the full extent of water ingress damage. It is probably wise to remove some of the soffit panels from these deck areas as well to get a visual inspection of the condition of the deck framing. Based on what we have seen above unit 108, it is likely that vinyl decking replacement will be necessary to the units currently being reviewed ( 206, 208, 210 ).

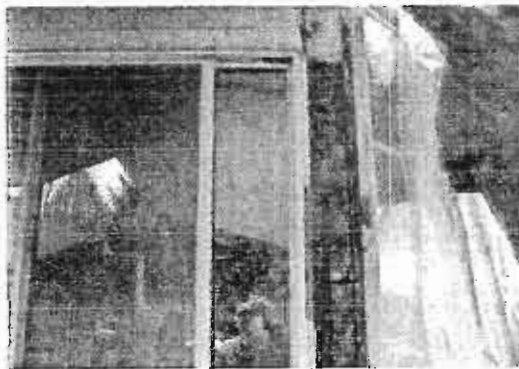
**Damage to Wall Beneath Deck Edge**

After further demolition at unit 108, the fuller extent of water ingress damage from above is visible. There is not doubt that the deck membrane and/or deck edge detailing has failed.

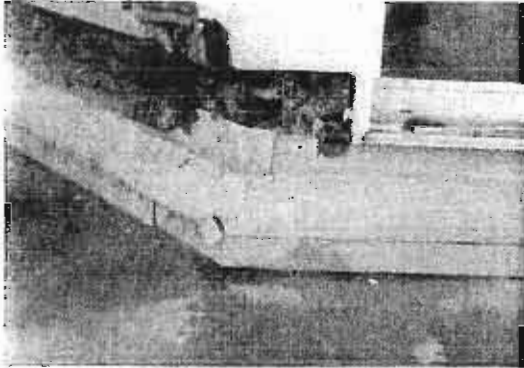
**Base of Wall Beneath Deck Edge 110**

The same type of damage seen at unit 108 is evident at unit 110 as well, which is directly below the deck edge of the unit above.

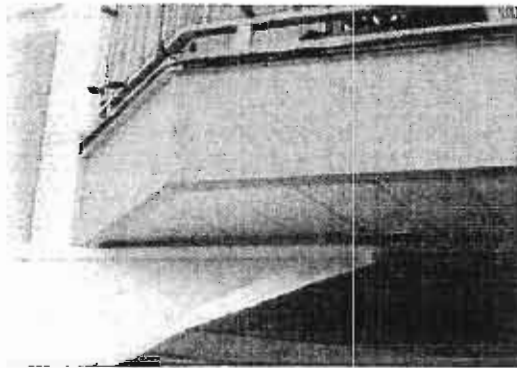
**Deck Edge At Unit 210**

Several issues are apparent from this photo: the deck vinyl has delaminated at the edge, there is missing flashing, and sealant has been applied in the past to attempt a repair at this location.

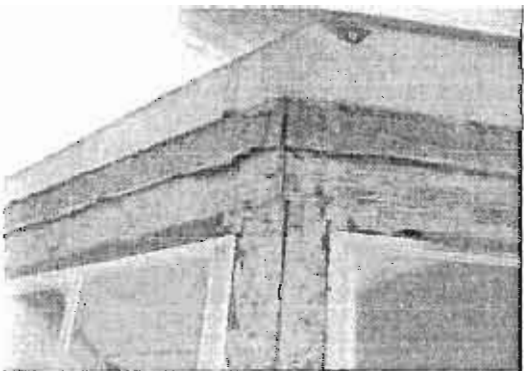
**Typical Sheathing Damage**

- 2) A visual inspection of some of the soffit areas of the decks along the East and South elevations show evidence of some water ingress.
- 3) Most of the OSB sheathing shows signs of water ingress damage with some surface mould growth underway. The damage is not severe and most areas can be remediate with cleaning only. There was a previous repair to the wall areas with a sealant installed into the expansion joint fitting. This has probably slowed the rate of damage to the wall considerably but has not repaired the existing and on-going damage from mould growth.

As can be seen from this photo, most of the OSB sheathing is still sound but has ongoing issues with mould spore growth and some water damage which can be cleaned and treated.

- 3) The exposed sheathing areas should be cleaned with bleach and treated with a Boracol solution to prevent any further mould growth. The existing window detailing and sealants are showing signs of failure, the strata may wish to consider a detailing upgrade which will locate and repair ongoing failures and provide long term protection to the building through proper window membrane, sealant, and flashing installations.

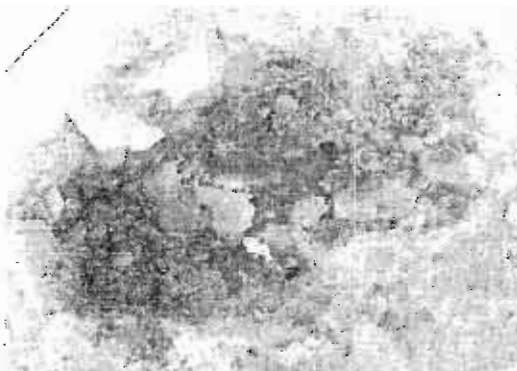
**Slab Membrane**

- 4) The Asphalt topping has been removed from the base of wall areas of units 108 and 110 so far. It appears that a concrete curb was poured on top of the suspended slab at the base of the wall. The area has been tapered off to prevent the rain from entering into this work area but it is evident that water is traveling underneath the existing membrane. This would indicate that the membrane is suffering from significant failure in the main field and water is most likely able to access and penetrate the curb at the cold joint between the curb and slab. A specific repair detail shall be prepared once demolition work has been completed.

Though it is somewhat difficult to see, water is traveling underneath the existing slab membrane to the edge of the base of wall.
