STRATA PLAN NWS 3379  
11595 FRASER STREET  
MAPLE RIDGE B.C  
V2X 0X7

**BUILDING ENVELOPE ASSESSMENT AND REPORT**  
March 8, 2007

**BRICKWOOD PLACE**  
**NWS 3379**  
11595 FRASER ST., MAPLE RIDGE, BC.

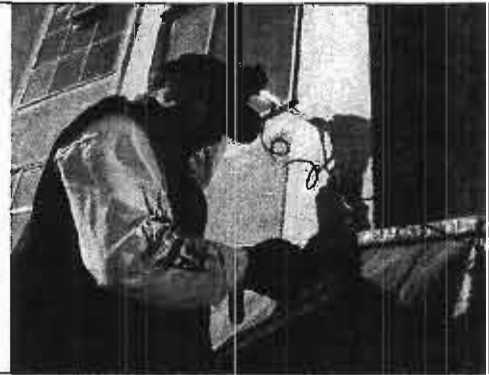
#### Photograph 1:

Moisture level readings were taken at deck edges and the bottom of window frames at all locations.

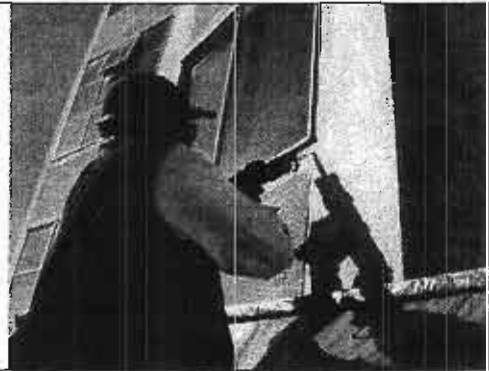
#### Photograph 2:

After a moisture reading or core hole reading has been recorded the hole is sealed.

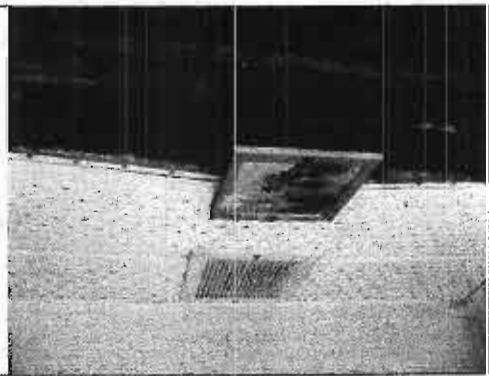
#### Photograph 3:

1. Aluminum soffit panels were removed from the underside of all of the deck areas. In many cases, the dryer vent exhausts through a soffit vent installed into the underside of the soffit. In every case, the duct work was not mechanically fastened to the exhaust vent, the vent was clogged with dryer lint, and the warm moist air from the dryer is venting directly into the joist area of the soffit. These areas were dripping with water and most had active and aggressive mould growth underway. Structural damage to the joist system was underway in several cases.

Dryer vent ducts in the balcony soffit areas are unsecured to the exhaust vent. As the vent clogs up the warm moist air enters into the deck joist cavity area.

2. We recommend that the dryer vent ductwork and exhaust system which currently exhaust beneath the deck surfaces be repaired and re-configured to prevent the dryer exhaust air from entering into the joist cavity. The duct work and exhaust vent must be sealed to prevent the warm moist air from escaping into the joist cavity. Some of the duct work is situated at different locations of the deck, therefore it may be necessary to design a repair detail which is adaptable to the specific repair requirements.

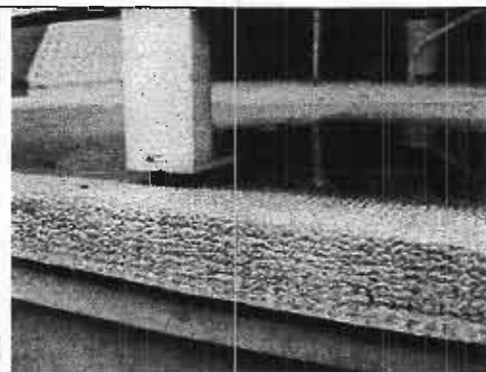
**Photograph 4:**

2. The deck railing systems are a "surface mounted" type, which is to say that the foot of the rail is fastened directly through the vinyl deck membrane and the holes are then sealed with a caulk sealant to prevent water from penetrating the deck surface. In most cases the sealant has not been maintained and has reached the end of it's serviceable life. In several cases water has penetrated the vinyl membrane and has caused structural damage to the joists and sheathing below.

The top mounted deck rail "foot" has pulled away from the PVC deck membrane at this location allowing water to penetrate the deck surface.

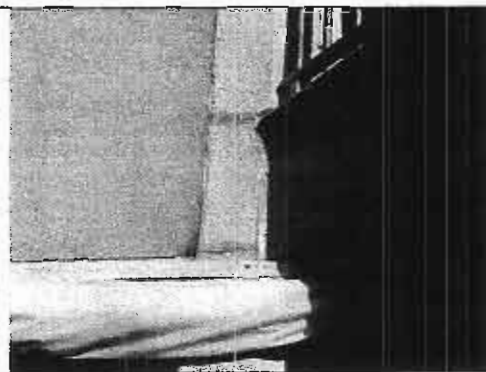
**Photograph 7:**

3. None of the deck areas incorporate a deck edge diverter to keep water from traveling along the interface with the stucco wall surfaces at the deck edges and instead rely upon a caulk joint at this location. This caulking has failed in many cases and water ingress damage is evident to joists, deck sheathing and wall areas at these locations. A previous repair was performed at several locations on the South and East elevations at the deck edges which did not prevent this type of water ingress. In the deck areas directly above units 106, 108 and 110 wall areas were opened up for inspection with several problems noted which include: insufficient vinyl "boot" at deck edge, back-lapped building paper and deck membrane, insufficient "tie-in" between new building paper and existing, no deck edge diverters. In the areas opened

This is an example of the typical deck edge detail showing how it relies upon a caulk sealant to keep water from entering into the building structure below.

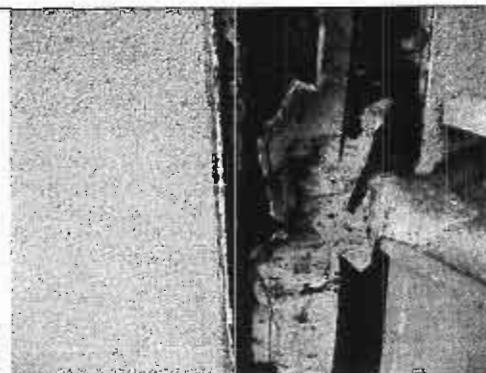
**Photograph 8:**

The same deck edge show in Photograph 7 above was taken apart to reveal an insufficient PVC deck membrane "boot", back-lapped building paper and deck membrane, no diverter at the deck edge, and an insufficient "tie-in" between the repaired area and the original building paper. The wall area behind the repair detail was water saturated.

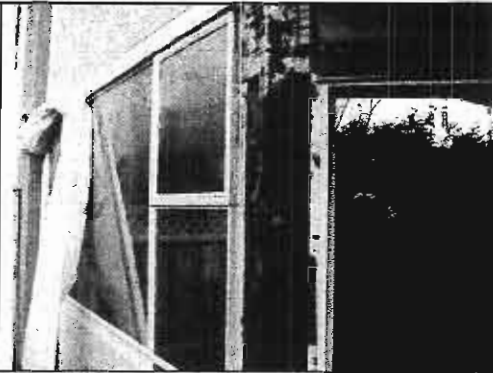
**Photograph 9:**

At the wall area directly below the deck edge shown in Photographs 7 & 8, the sheathing and framing members were water saturated and significantly rotten. A similar wall condition was found in most areas below the deck edges.

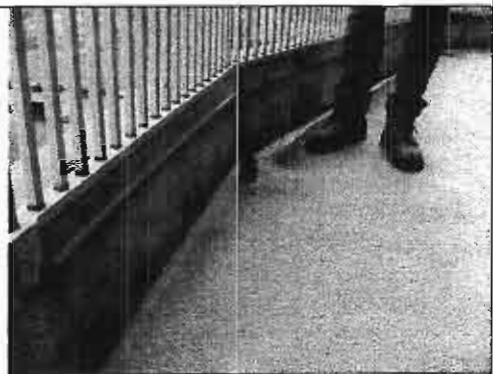
**Photograph 11:**

- There were four large soft and spongy areas of the deck surface which indicate the deterioration of the deck sheathing below.
  - There was no deck overflow scupper to the deck area.

- This is a large cantilevered deck area with a support beam running perpendicular to the building at about the centre point. The soft deck areas are above this beam location and damage to this beam must be considered as serious.

The deck area at unit 416 has several soft spots and water ponding.

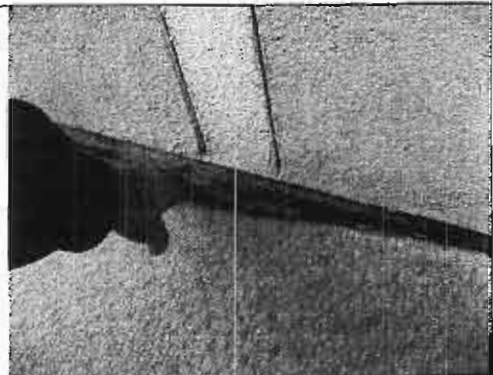
**Photograph 12:**

- The vinyl had been replaced previously with a new surface placed over the previous surface. This installation terminated under the stucco stop only ( 1-1/2" upturn ) and was de-bonded along its entire length allowing water easy access to the wall and deck surface below.

The repaired PVC vinyl deck membrane was installed without an upturn at the deck edge and simply cut-off at the underside of the stucco "J". This edge is delaminated and allowing water easy access to the wood framing structure below. This type of practice was evident at all decks where the membrane had been previously repaired / replaced.

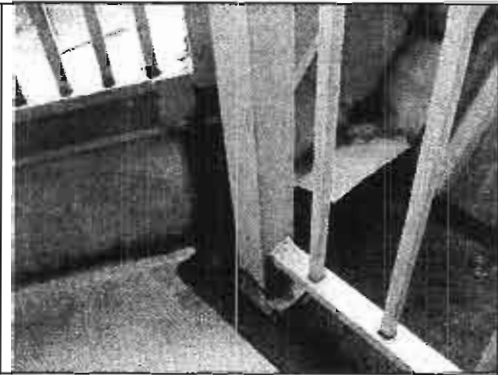
**Photograph 13:**

- The pitched roof area to the south of the deck area drains onto the deck surface and uses some questionable roofing and membrane practices. Roofing membrane has been bonded on top of the vinyl decking, there is a back-lapped and loose roofing membrane allowing water penetration, and ill-fitted flashing components.

The pitched roof area to the South of the deck at unit 416 incorporates some very questionable practices in joining together and attaching the various non-compatible components.

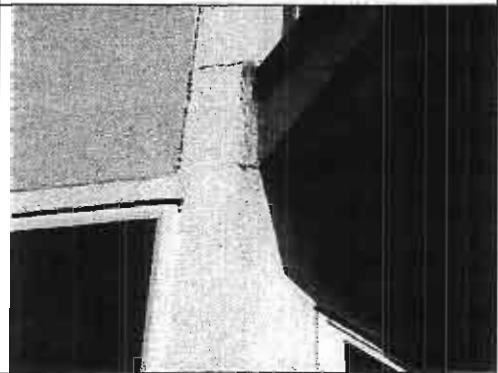
**Photograph 14:**

6. The stucco surface expansion joints on the East, South and North elevations have been sealed with a clear caulk sealant at some time in the past. For the most part, this sealant seems to have worked well but is starting to reach the end of its serviceable life. Some areas are now missing and / or delaminated and will begin to allow water ingress if left unattended. In general, all the caulking observed on the building appears to have reached the end of its serviceable life and is starting to crack and / or delaminate.

The caulk sealant which was added during a previous repair into the stucco expansion joints and at the deck edges has started to crack and delaminate.

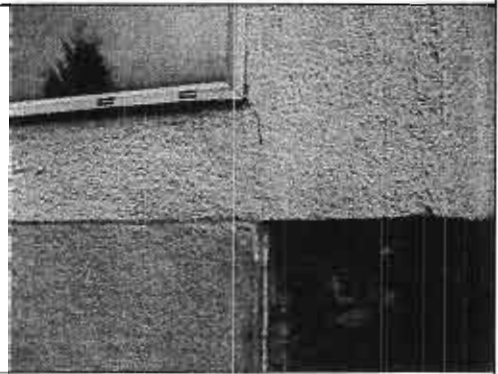
**Photograph 15:**

9. The stucco has been applied directly to the edge of the aluminum windows on the East, South and North elevations. Due to the course of expansion and contraction from drying materials and weather condition changes over time, a crack has opened up at most window jamb and sill locations. The windows installed into the vinyl clad areas of the East elevation are not affected in this way, however, none of the vinyl "J's" were sealed to the window frames with an appropriate exterior caulk sealant. A few of the wall areas around the windows were opened up for inspection in both stucco and vinyl clad areas. In the stucco clad areas the building paper was brittle and indicated some exposure to moisture. In the vinyl clad areas, the building paper appeared to be in reasonable condition. No water proofing membranes were observed in the window installations.

Cracks are opening up where the stucco has been applied directly to the edge of the window frames.

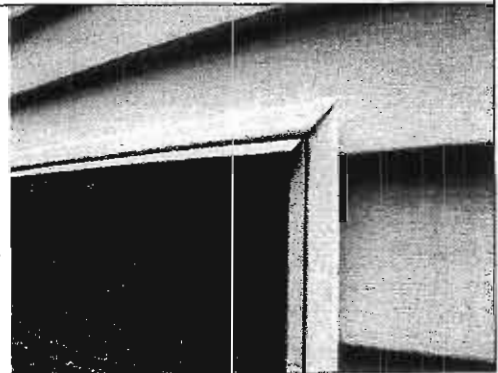
**Photograph 16:**

Very small window head flashings were incorporated into the window detail in both vinyl and stucco clad areas. No caulk sealant has been applied at the jambs or sills of the window areas in the vinyl clad areas.

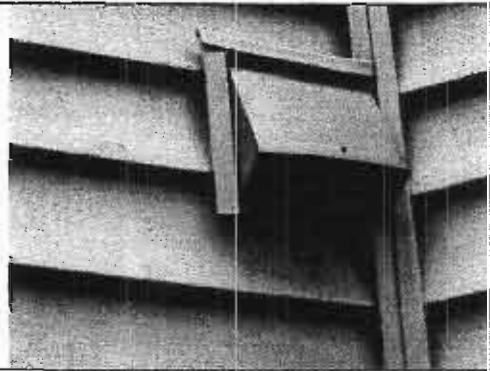
**Photograph 17:**

8. In both the vinyl siding and stucco clad areas, exterior exhaust vents are not caulked or flashed in properly with the siding or stucco and were not sealed at the wall penetration at the building paper. In the areas of wall where water ingress of some degree was noted, 3 of 7 areas were at vent locations.

No head or sill flashings, sealants or membrane work was seen at any of the vent or wall penetrations in either vinyl or stucco clad areas.

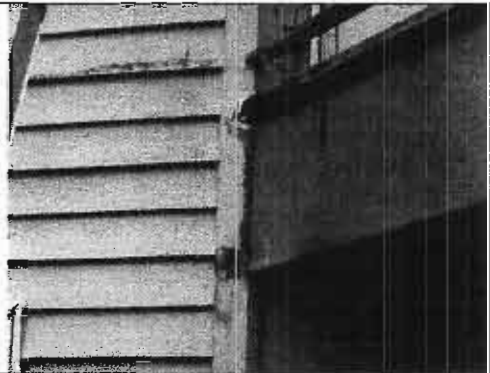
**Photograph 18:**

Deck edges in the vinyl clad areas rely heavily upon a caulk sealant to divert water at the deck edges. Heavy algae growth and deck vinyl membrane delamination was evident on the East elevation wall and deck areas.

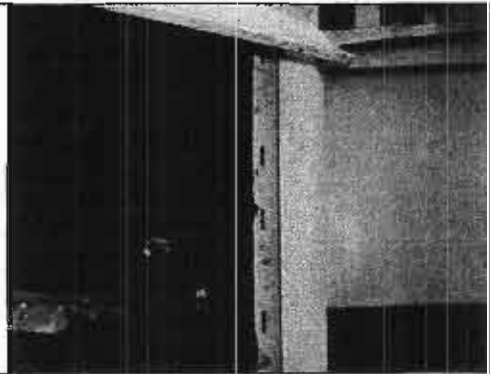
**Photograph 19:**

Poor detailing at the deck edges was evident when the vinyl siding was removed. None of these decks appear to have been remediated previously. Most deck edges were water saturated but did not generally show the same level of aggressive deterioration as the stucco clad areas.

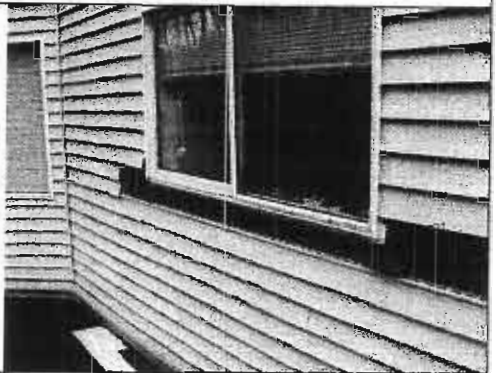
#### Photograph 22:

The exposed wall areas around the windows show the building paper and window installation detailing. No water proofing membrane installation was evident.

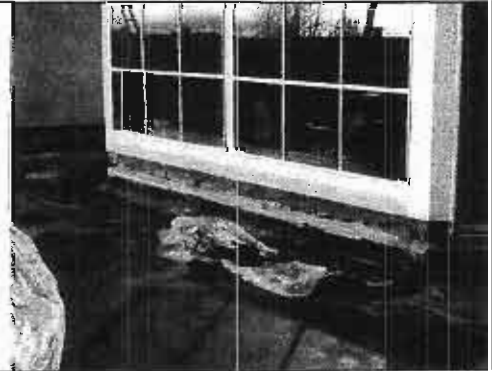
### Photograph 23:

The slab and asphalt topping and base of wall curb were exposed at the base of wall at units 106, 108 and 110

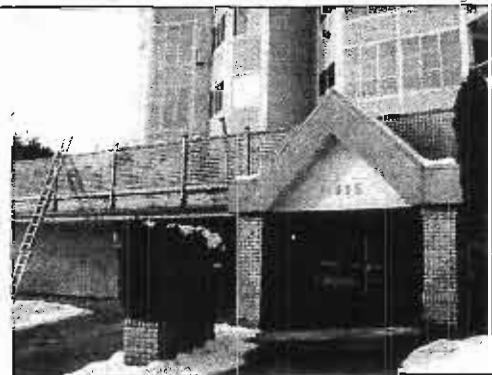
### Photograph 24:

The suspended slab edge at the South East corner shows the attached fence rail system, the gutter system, the underground garage access area, and the main building entrance.

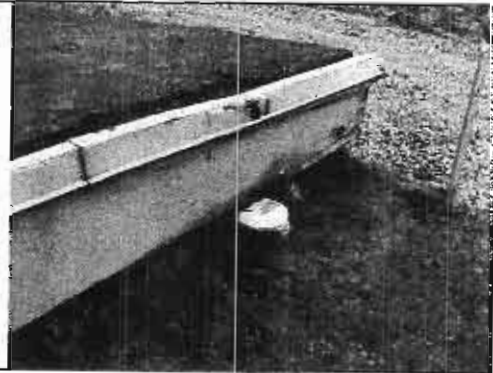
### Photograph 25:

The slab edge detail is exposed at the NE corner showing the fascia board, cap flashing and asphalt topping.

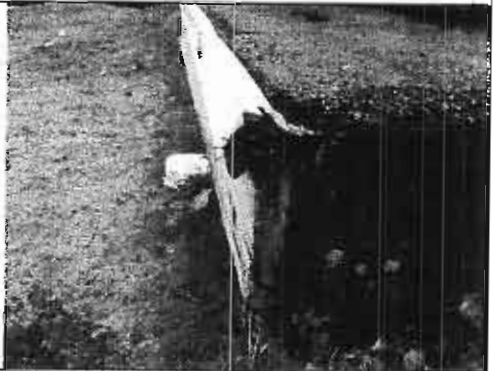
### Photograph 26:

A section of this detail shows how the various components can trap water at the slab membrane.

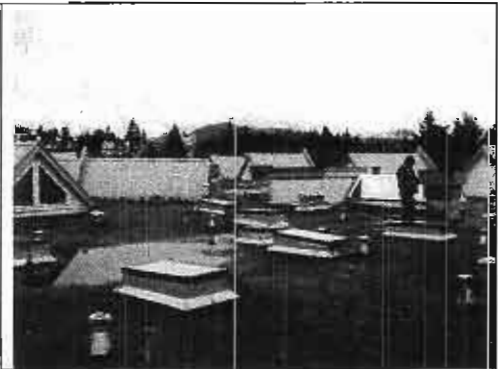
#### Photograph 27:

This photo shows the general components of the roof area which include the flat roof area, the pitched metal clad roof areas, the sky-lites, vents and air handling units.

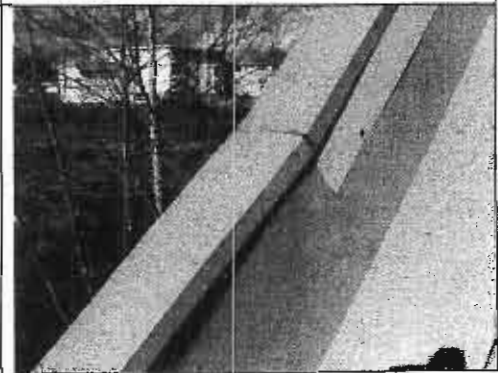
#### Photograph 28:

1. The roof curb edge flashing was installed in a continuous fashion around the roof edge creating a back-lapped seam condition at each of the 13 pitched roof areas. As the caulk sealant has become brittle and failed, water is being allowed into the roof curb area.

Back-lapped flashing installation typical at each to the pitched roof areas.

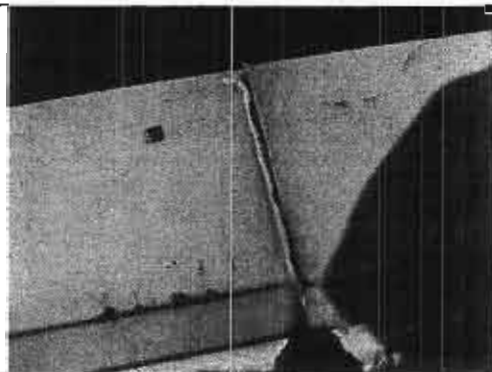
**Photograph 30:**

Caulk sealant at all exposed roofing areas has become brittle and delaminated. Water will soon find its way through these flashings into the building's wood frame structure and undermine the existing roofing membrane.

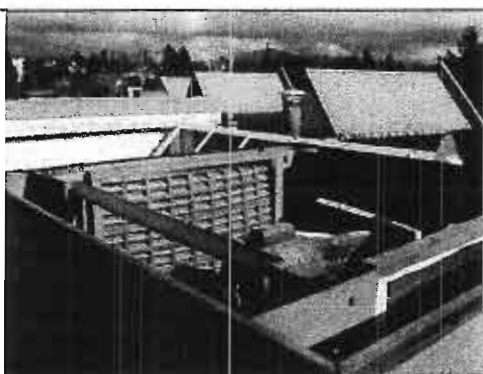
**Photograph 35:**

The roof top air handling units were opened up. The air filters were clogged with debris and had collapsed into the unit. The fan belts on the unit were loose and were showing some wear.

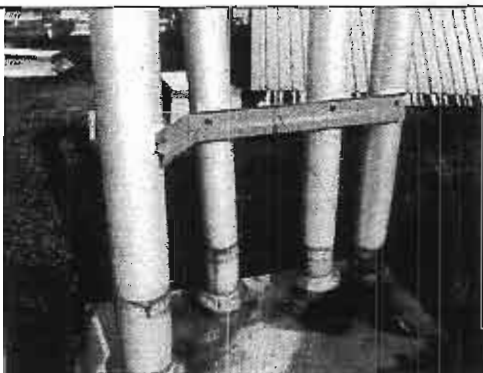
**Photograph 36:**

B-vents which were extended were not supported correctly and could easily become unattached.

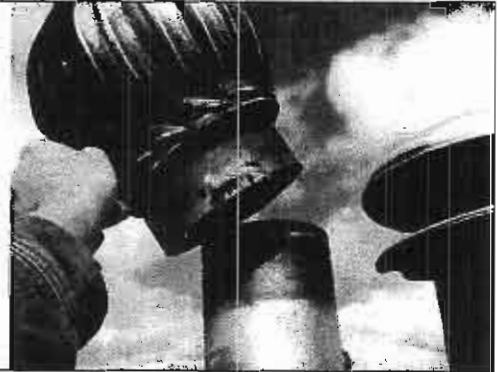
**Photograph 37:**

**B-vent caps were loose and some were ill-fitted and unsecured.**

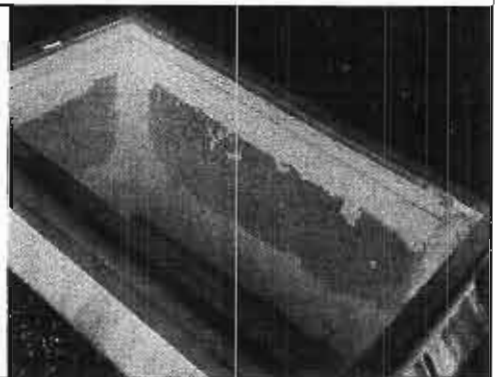
**Photograph 38:**

have interior drywall and paint damage visible around the sky-lite. This damage could be caused by leaks or from high interior moisture levels and condensation during colder months.

**Damage to paint and drywall was evident at most of the sky-lite areas.**

10. Moisture damage which is evident at the roof top sky-lite features is probably due to condensation resulting from high interior moisture levels during colder winter months.

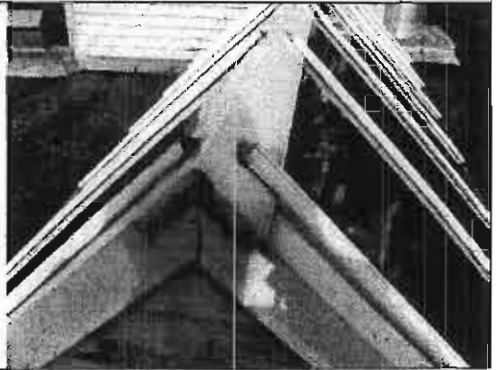
**Photograph 39:**

**The common area sky-lite relies upon the caulk sealant to maintain water tightness. This sealant is showing signs of failure and brittleness. Normally a unit of this type would incorporate an flashing cover at its apex.**
